Inspection Report

**122 & 124 Allen Street
Arroyo Grande, CA 93420**

Gregory S. Terry

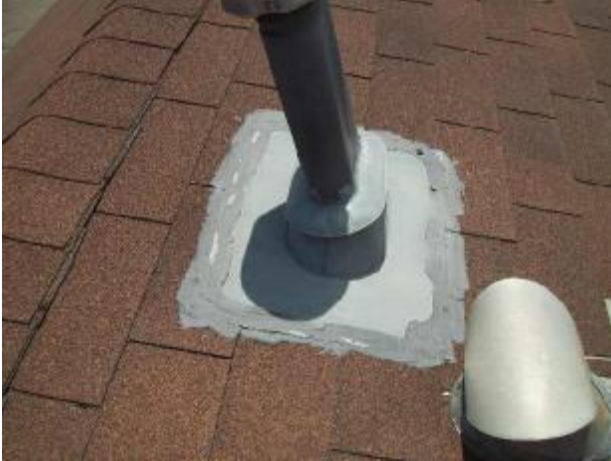
R

1.) The flashings for both of the wall heater exhaust flue vents have been improperly installed.

Improper flashing at the wall heater vent flue.

COMPONENT	CONDITION	ACTION RECOMMENDED	PERSPECTIVE
1	Roof coverings: Acceptable		
2	Ventilation: Acceptable		
3	Flashings: Most Acceptable	Recommend further Evaluation by a Roofing Contractor	Potential Leak
4	Skylights: N/A		
5	Chimneys: N/A		
6	Gutter system: N/A		
7	:		
8	:

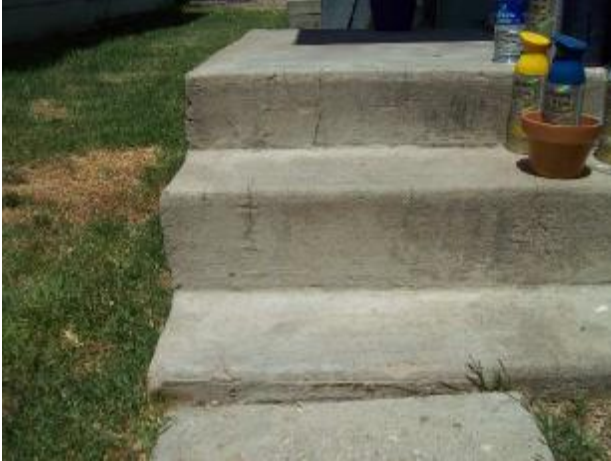
GD

Safety Hazard Note: There are inconsistent riser heights at the front and rear entry stairs for both of the Units. This can be a falling hazard. The maximum allowable difference between risers is 3/8 inch.

Example of the inconsistent riser heights at the front entry and rear entry concrete steps.

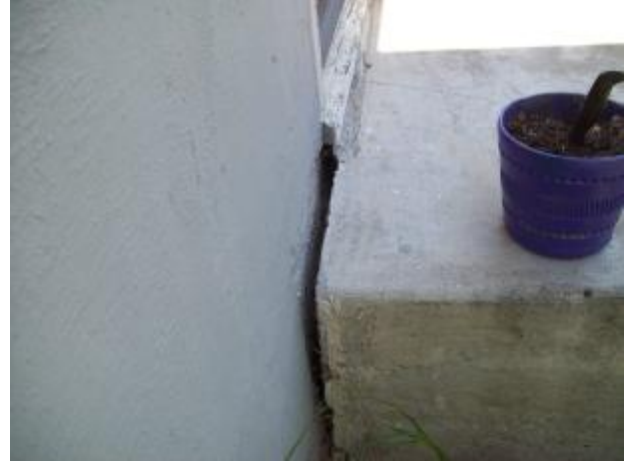
GD

- 1.) There is moisture damage to the base of the front entry overhang support posts at Unit 124.
- 2.) All four of the concrete landing at the front and rear entries have settled and pulled away from the exterior walls.
- 3.) The fencing is leaning at the east side of the property.

Example of one of the concrete stoops that has settled and pulled away from the building.

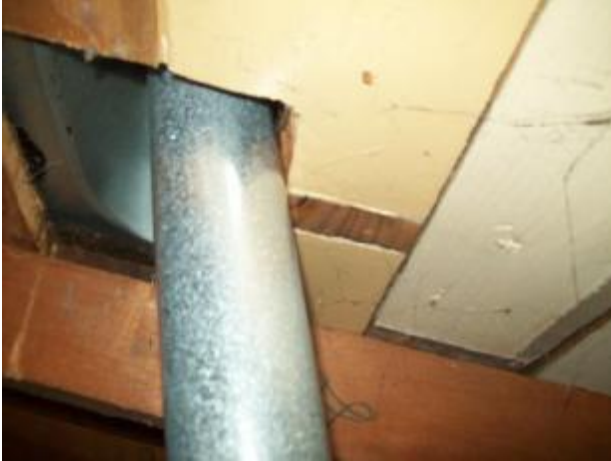
HC

Fire Safety Hazard Note: The vent flue for both of the wall heaters do not maintain the proper minimum 1 inch clearance to the combustible framing as the vent penetrates through the roof.

Improper clearances to the combustible roof framing as the wall heater vent flue passes through the roof.

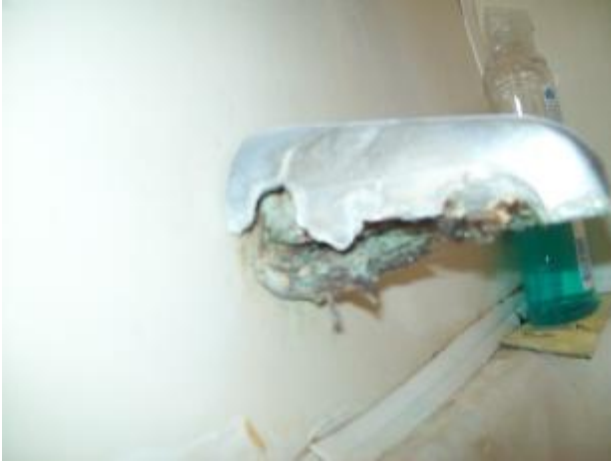
B

Corroded spout at the bathtub in Unit 124.

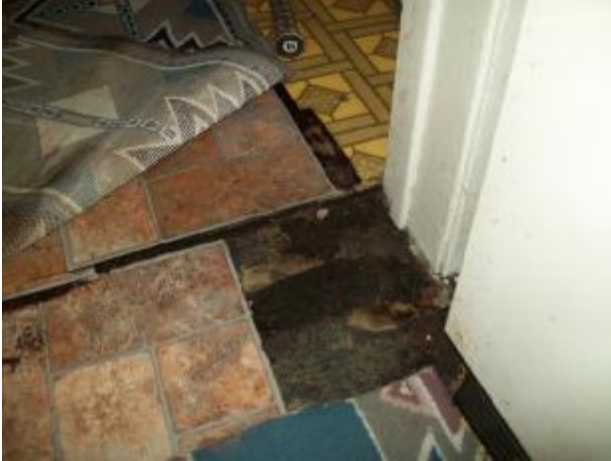
IR

Moisture damage to the subflooring in the laundry room in Unit 124.

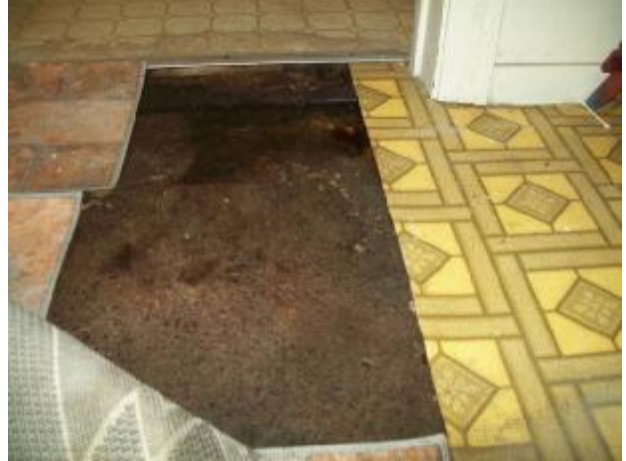
IR

Moisture damage to the subflooring in the laundry room in Unit 124.
